# **Debris/Ice/TPS Assessment and Integrated Photographic Analysis of Shuttle Mission STS-83**

**DEBRIS/ICE/TPS ASSESSMENT  
AND  
INTEGRATED PHOTOGRAPHIC ANALYSIS  
OF  
SHUTTLE MISSION STS-83**

**4 April 1997**

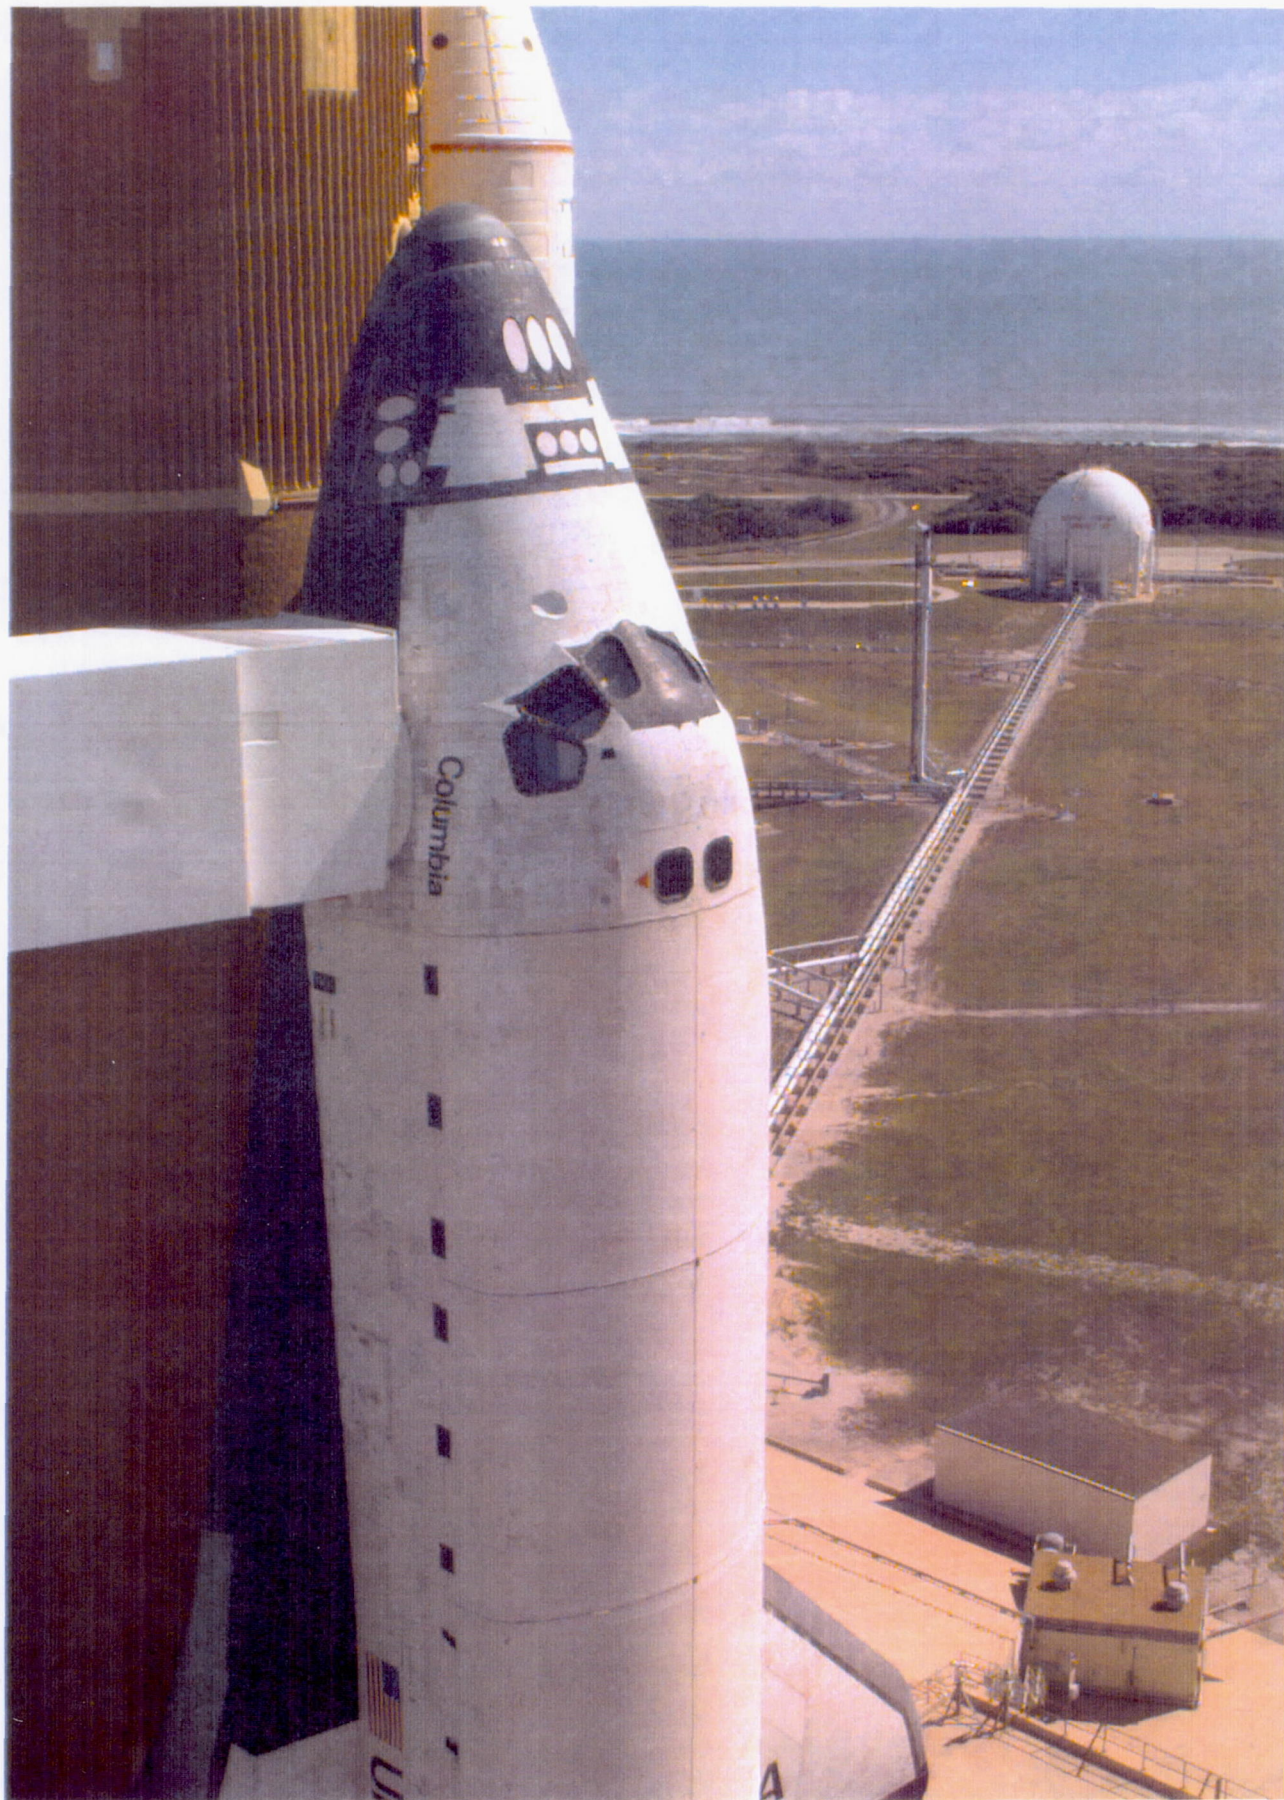
**Photo 2: STS-83 Ready for Launch**

OV-102 (22<sup>nd</sup> flight), ET-84 (LWT 77), BI-086 SRB's

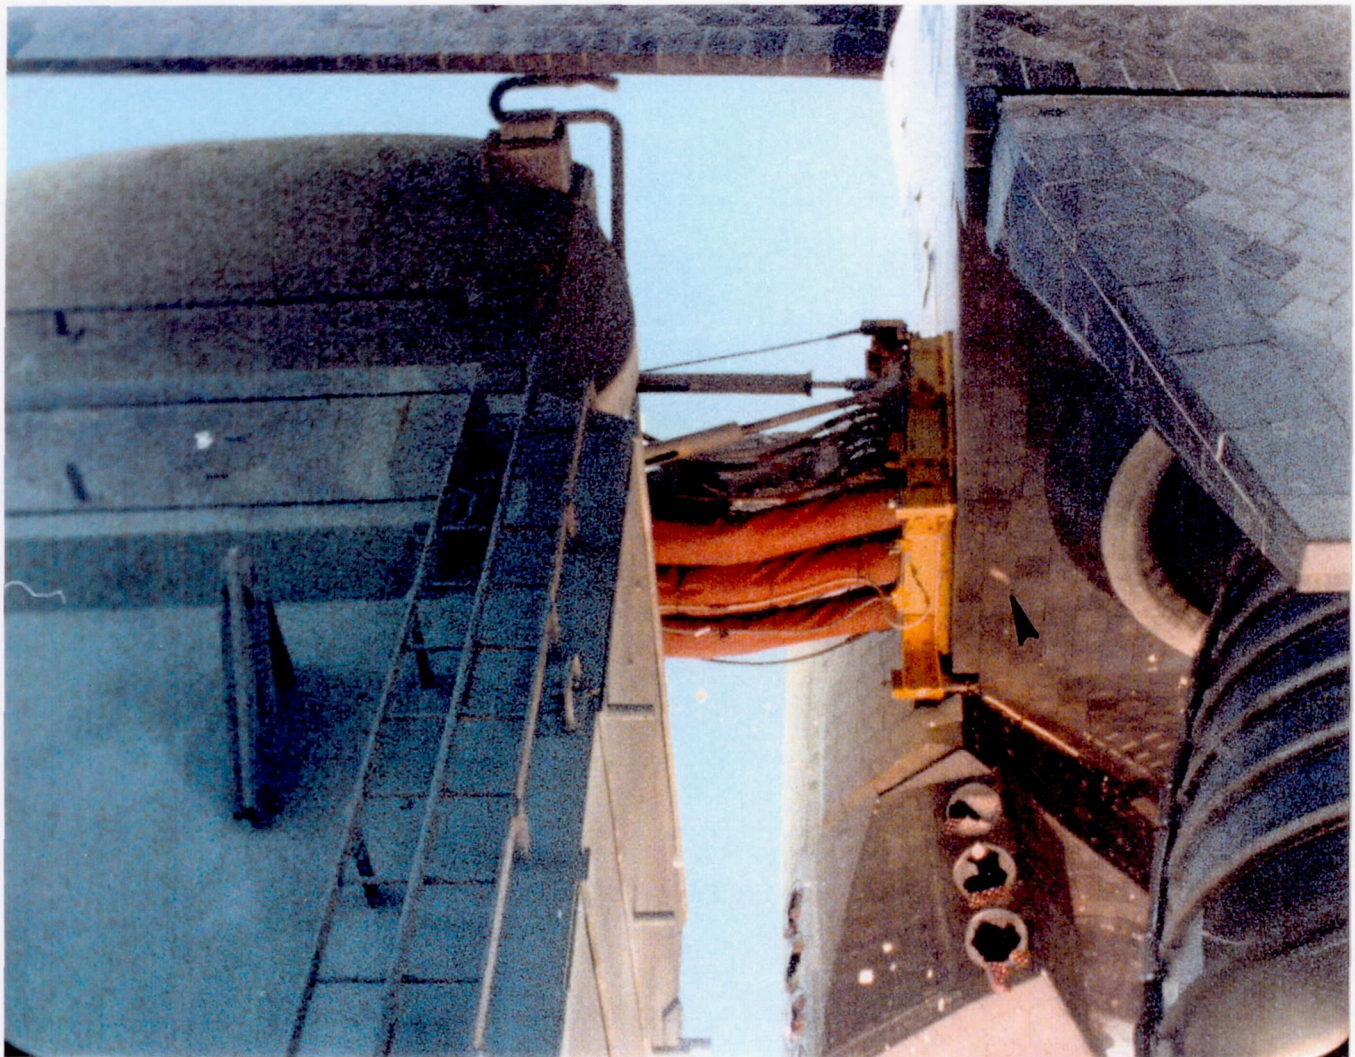
**Photo 8: Tile Gap Filler**

A thin, 5-inch long by 1-inch wide object appeared from the base heat shield area behind SSME #3 and fell aft at 19:20:29.416 UTC. The object was more flexible than a GSE tile shim and may have been a tile gap filler.

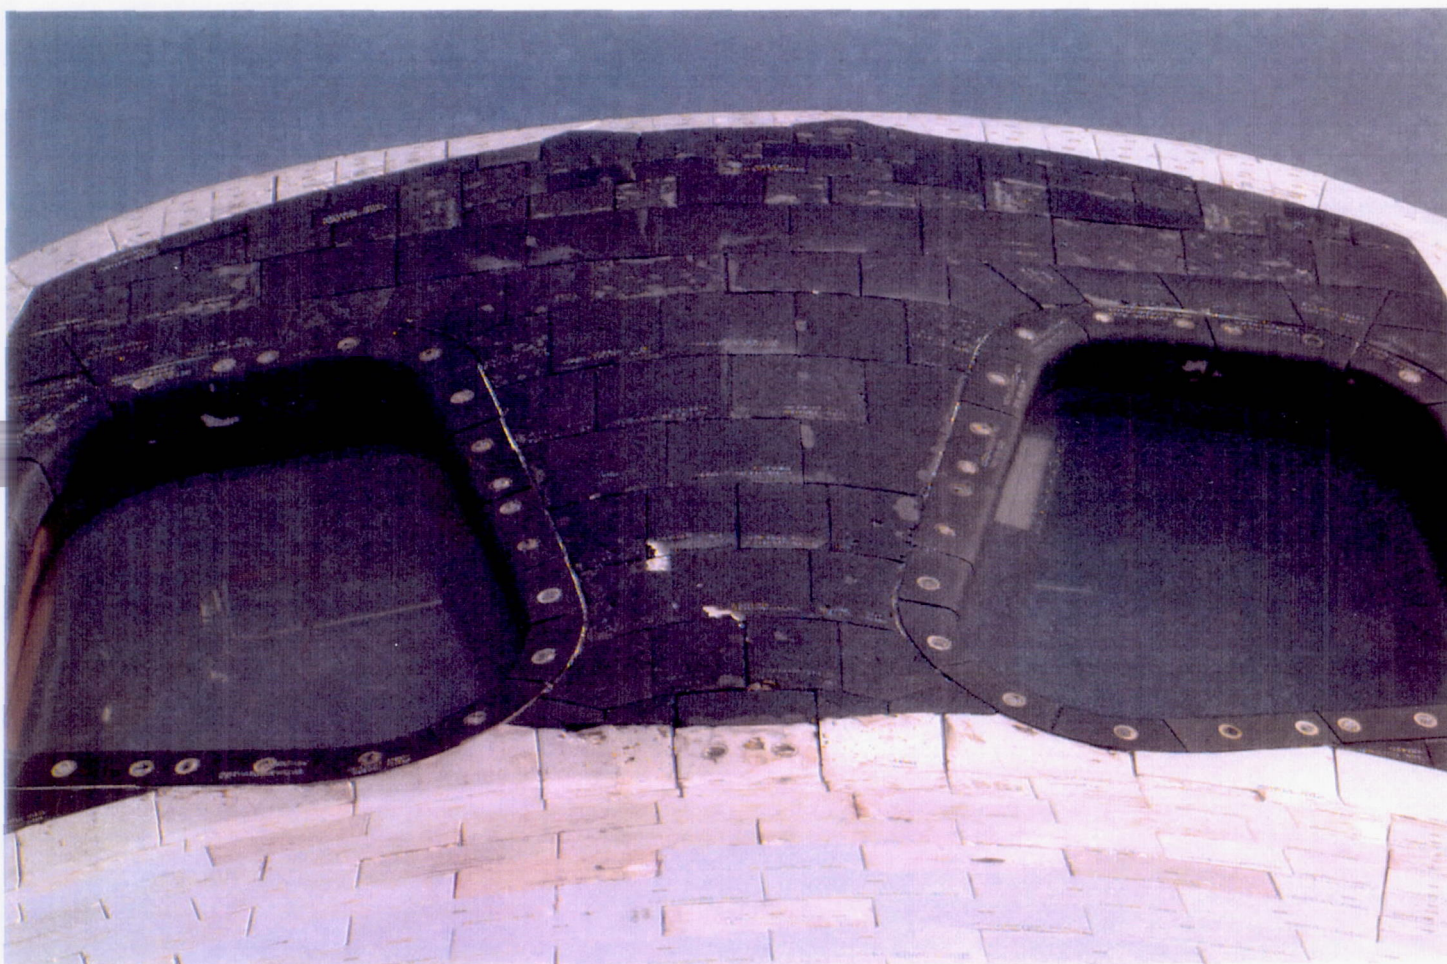
**Photo 23: Orbiter Windows #3 and #4**

Hazing and streaking of forward-facing Orbiter windows was typical. Damage sites on the window perimeter tiles appeared to be greater than usual in quantity and size. Two damage sites greater than 1-inch in size within a cluster of 11 hits were present in the black tile area between windows #3 and #4. These damage sites are believed to be the result of impacts from excessive RTV adhesive used in attaching paper covers to the FRCS thrusters.

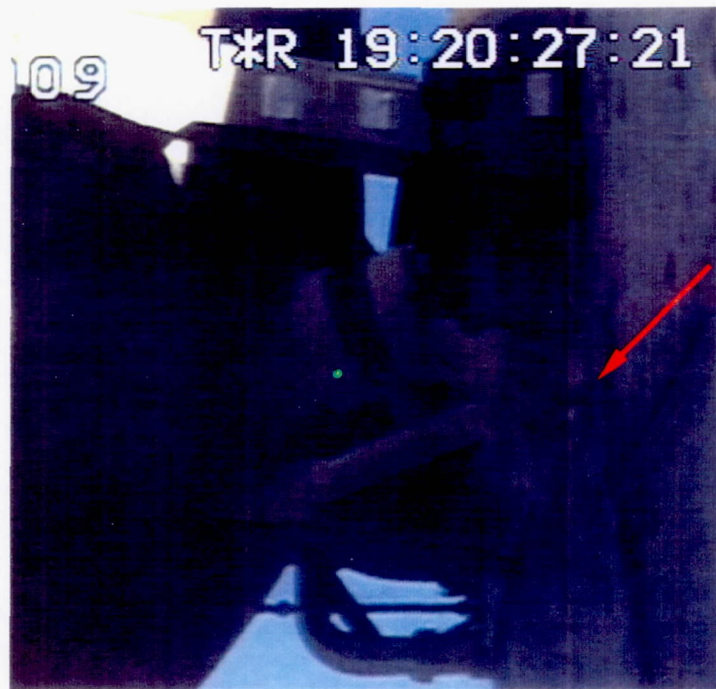
Figure 2.1 (A) Ice Debris Strike to Umbilical Well Door Sill

Multiple pieces of ice debris from the LH2 ET/Orbiter umbilical were seen falling past the body flap during SSME ignition. Ice debris was seen to strike the LH2 umbilical well door sill (19:20:27.7 UTC). No damage was noted (Camera OTV009).

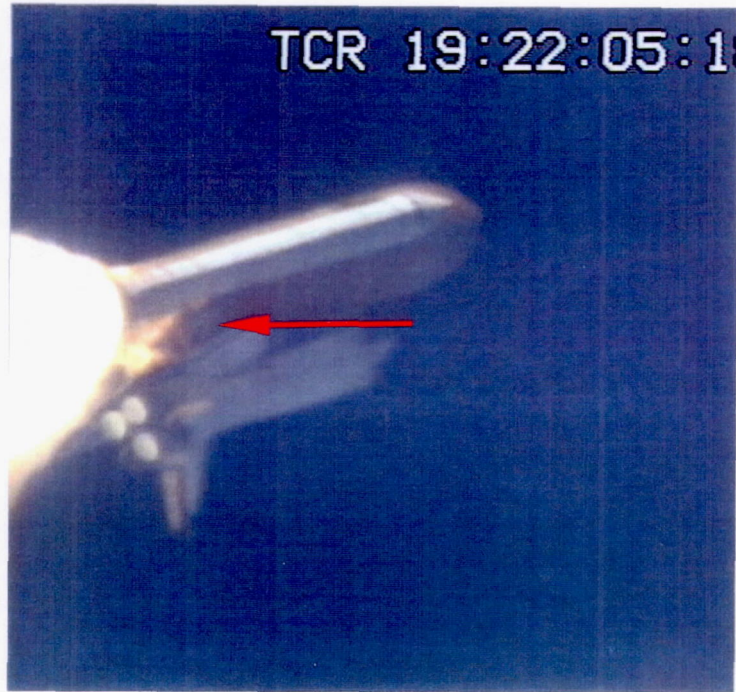
Figure 2.4 Recirculation at Aft End of Vehicle

Recirculation, or the expansion of burning gasses at the aft end of the vehicle, was seen during ascent (19:22:04.7 - 19:22:18.1 UTC). Recirculation during this time period has been seen on previous missions (Cameras KTV13, ET204, ET208, ET212, E212).
